CCS 水电站引水隧洞 TBM 断层带卡机脱困技术

摘要:厄瓜多尔 CCS 水电站引水隧洞采用大直径双护盾 TBM 施工, 开挖洞径 9.11 m, 在掘进至桩号 K16+127.0 m 时, 由于断层破碎带围岩塌方掩埋及堵塞刀盘造成卡机事故。在分析地震法物探成果和钻孔岩芯的基础上, 确定断层破碎带及影响带宽度约 70 m, 围岩稳定性差, 以 IV 类为主, 局部 V 类。拆除刀盘后方 16.26 m 处管片的上半部分后, 沿洞壁两侧开挖旁洞, 至刀盘后沿引水隧洞轴线进行导洞顶拱扩挖直至通过断层破碎带, 导洞开挖前采用超前锚杆、固结灌浆等超前支护措施, 开挖后采用钢拱架、系统锚杆、挂网喷射混凝土支护措施; 支护完成的导洞防止了 TBM 掘进时的洞顶塌方, TBM 在断层破碎带内掘进时, 每环掘进前均对掌子面前方围岩进行固结灌浆以防掌子面围岩塌方; 采用以上技术措施后, TBM 成功脱困并穿过了断层破碎带。

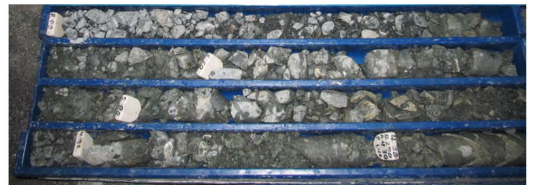
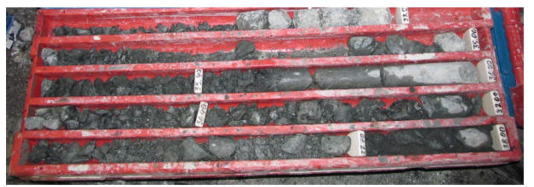
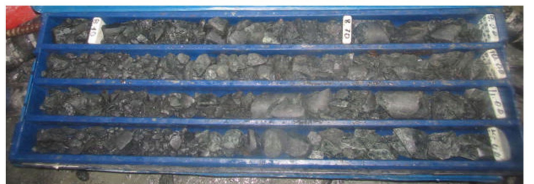
图6 钻孔部分岩芯

为进一步确认掌子面前方围岩地质条件,在掌子面附近洞壁两侧的旁洞内向前方水平钻孔,钻孔方向与洞轴线平行。GA1 钻孔位于右侧旁洞,钻孔深度 61.0 m,对应隧洞桩号 K16+128.7 m ~ K16+67.7 m;GA2 钻孔位于左侧旁洞,钻孔深度 50.2 m,对应隧洞桩号 K16+132.6 m ~ K16+82.4 m。钻孔方式为回转清水钻进绳索取芯,采用“多回次,少进尺”的方法,提高岩芯采取率。对钻进岩芯现场编录,编录内容主要包括岩石的颜色、矿物成分、风化程度、坚硬程度等,并对节理、裂隙发育情况及裂隙面特征、充填胶结情况进行描述统计,计算岩芯采取率、岩石质量指标(RQD)等定量指标,评价岩体质量。钻孔部分岩芯如图 6 所示。

(a) GA1 钻孔 4.0 ~ 8.0 m 岩芯

(b) GA1 钻孔 33.0 ~ 38.0 m 岩芯

(c) GA2 钻孔 8.0 ~ 12.0 m 岩芯

(d) GA2 钻孔 28.0 ~ 32.0 m 岩芯

根据钻孔岩芯编录资料,可以看出 2 个钻孔岩芯破碎,岩芯 RQD 值较低,在破碎段一般低于 20%,岩石强度低,同时结合旁洞开挖揭示的地质情况(图 7),判定引水隧洞桩号 K16+131.0 m ~ K16+61.0 m 处发育有一断层。断层破碎带及影响带宽度约 70 m,断层带岩性主要为深灰色安山岩,岩体破碎,呈镶嵌~碎裂~散体结构,多处可见断层泥、糜棱岩及碎裂岩,地下水不发育。断层产状 $10^{\circ} \angle 78^{\circ}$,与引水隧洞轴线小角度相交,对隧洞稳定性不利(图 8)。综合物探、钻孔岩芯及旁洞地质编录资料,认为断层破碎带及影响带按照 RMR 围岩分类标准以 IV 类围岩主,局部夹泥段为 V 类,围岩自稳时间短,自稳能力差,TBM 掘进时,在刀盘的扰动下,洞顶及掌子面极易塌方。

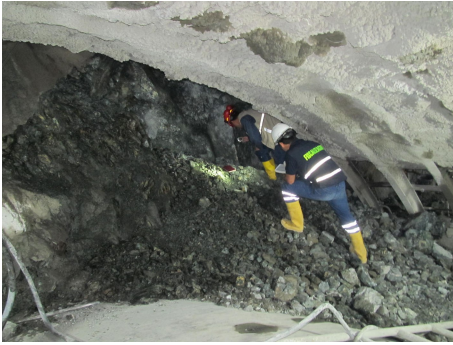
图 10 顶拱扩挖支护后情况

采用开挖扩大顶拱并加强支护的措施后,顶拱围岩在掘进过程中,未出现较大的变形,支护措施满足了围岩稳定性的要求。TBM 在断层破碎带内掘进时,顶拱围岩不再塌方,仅掌子面出现了少量的塌方,但对掘进影响较小。从卡机到恢复正常掘进,共历时 173 d。

g. 扩大顶拱开挖前采用直径 25 mm、长 6.0 m、间距 35 cm 的自进式锚杆对顶拱进行超前加固,同时对围岩进行固结灌浆处理。开挖后进行钢拱架支

护,钢拱架为 120 工字钢,纵向间距 50 ~ 80 cm,采用直径 25 mm、长 4.0 m、间距 1.0 m 的系统锚杆对顶拱进行系统支护,同时挂网($\phi 6@0.15\text{ m}\times 0.15\text{ m}$)喷 10 ~ 15 cm 厚 C20 混凝土。扩大顶拱开挖支护后的情况见图 10。
